Silvercladd

- ✦ These slides depict some of the important details, of any type of insulation installation; highlighting the problems which can occur when applying Silvercladd, foil and parts.
- ✦ Left side: good installation; and
- ✦ Right side: bad installation

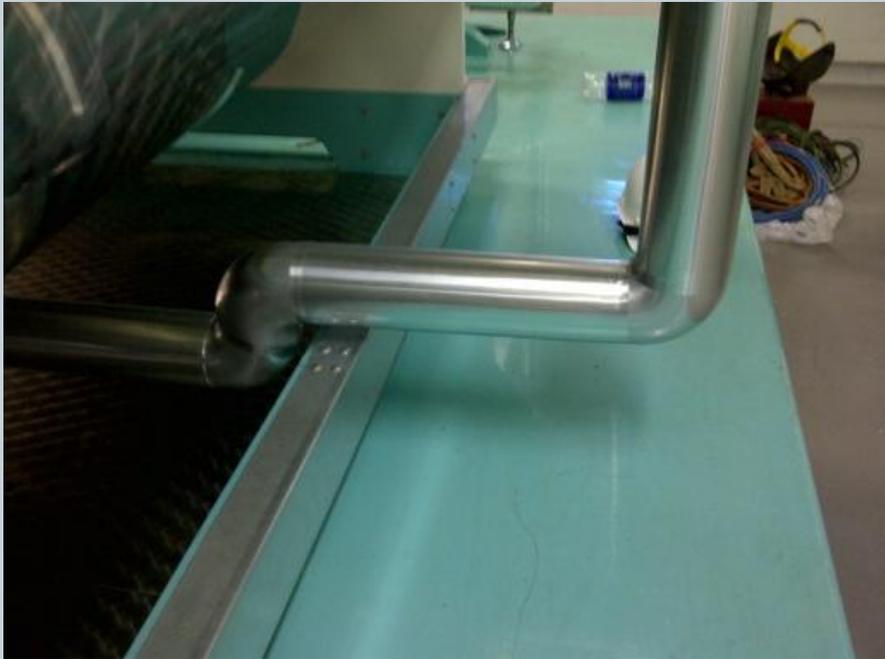
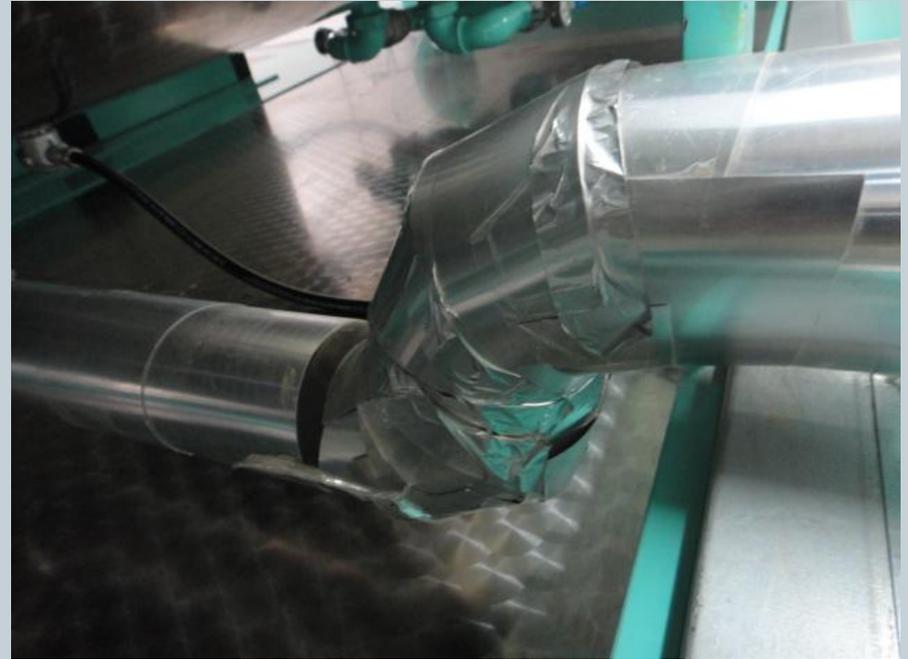
- To the right: proper elbows missing, unsatisfactory tape application, exposed insulation
- To the left: elbows supplied and re-installed, tape neatly placed free of wrinkles, encapsulating the system for an easy wipe-down of pipes. Tape used as per food facilities, eliminating the amount of joints which could accumulate dirt, creating a seamless pipe system.

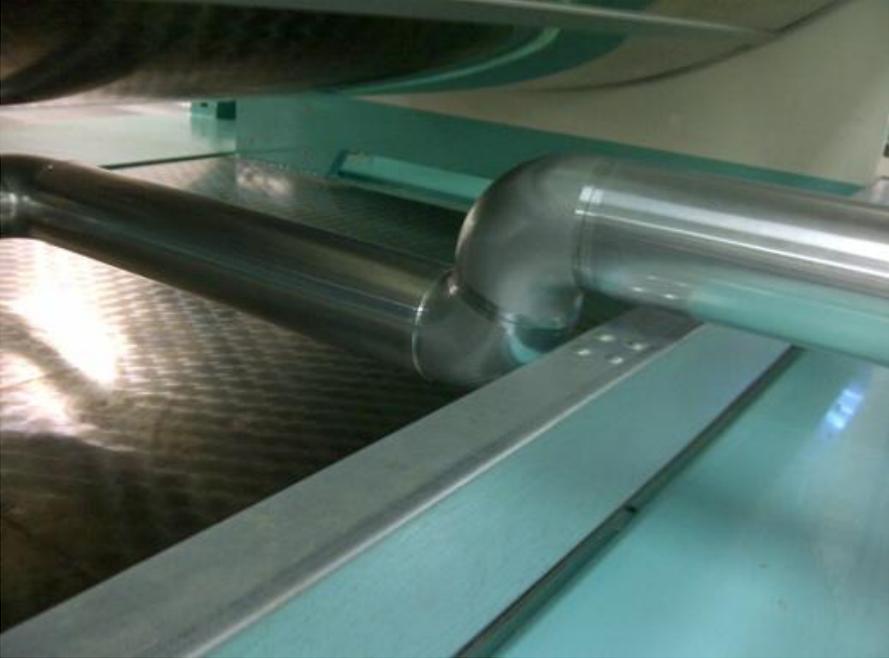
Another close up of the previous slide.

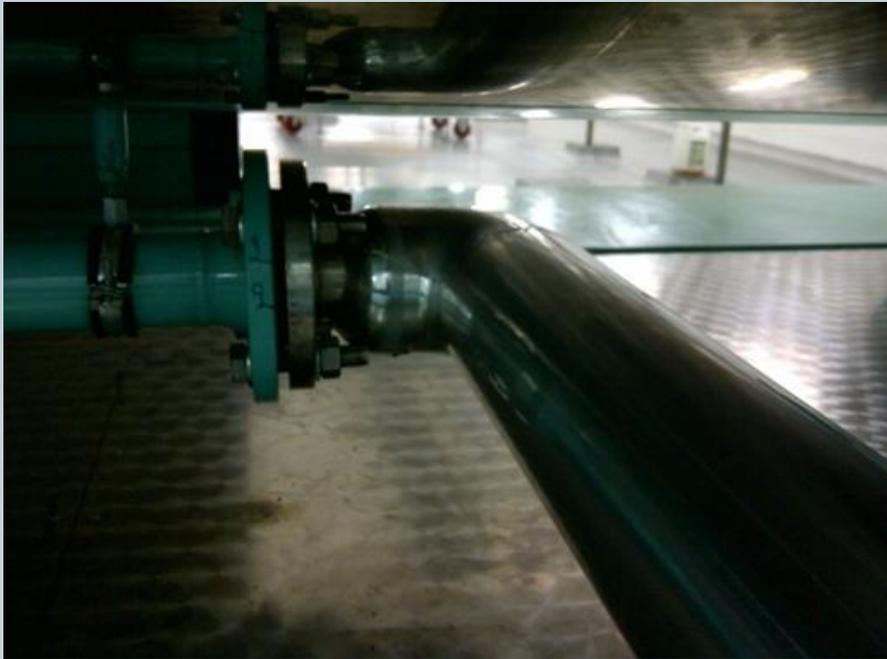
- To the right: end cap missing, insulation exposed, no space for flange maintenance

- To the left: end cap installed, space allowed around the flange for maintenance reasons.

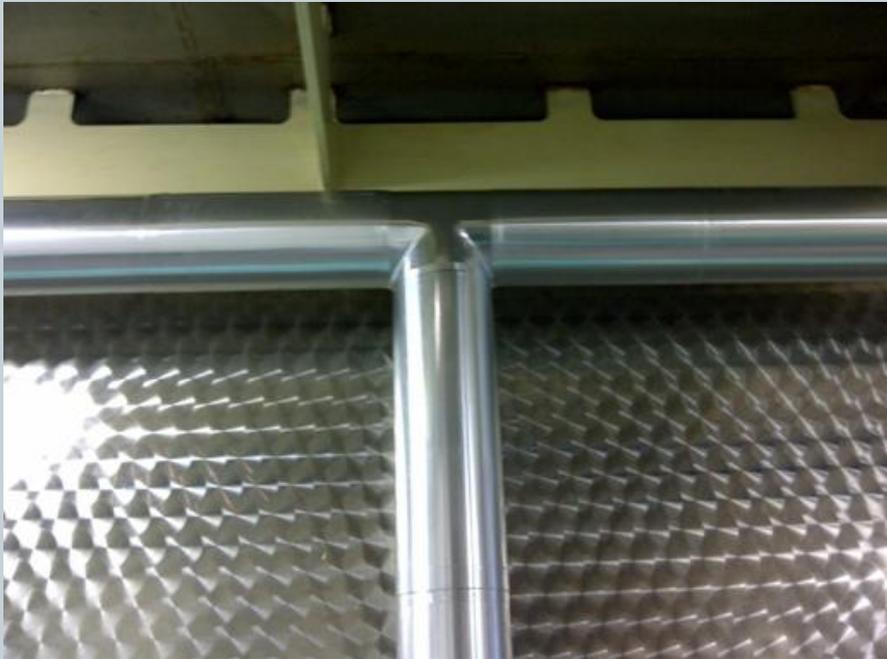
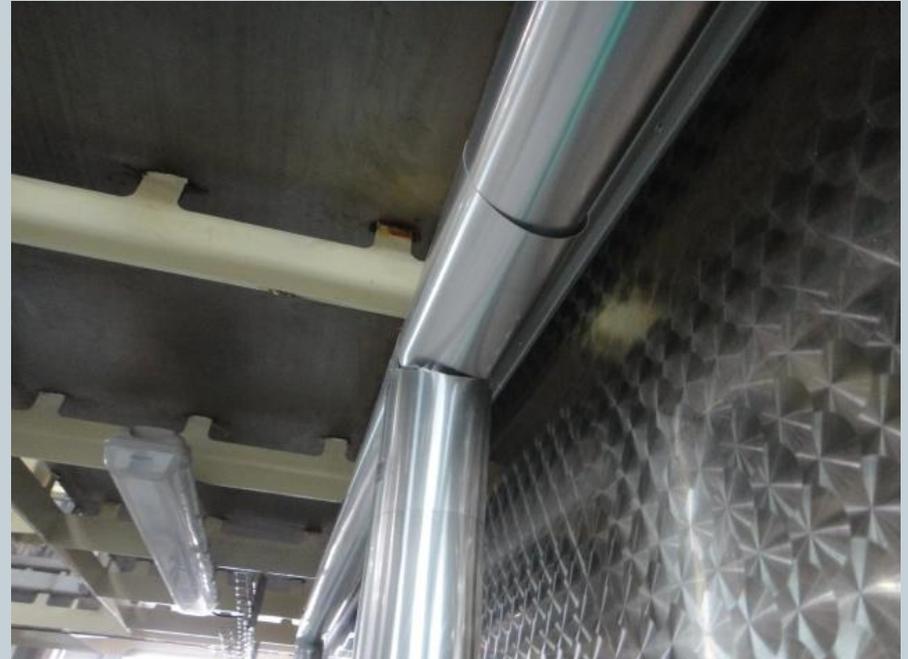
- To the right: T-piece not cut properly, visible gaps, insulation exposed
- To the left: Prefabricated T-piece supplied and installed, straight jacket redone

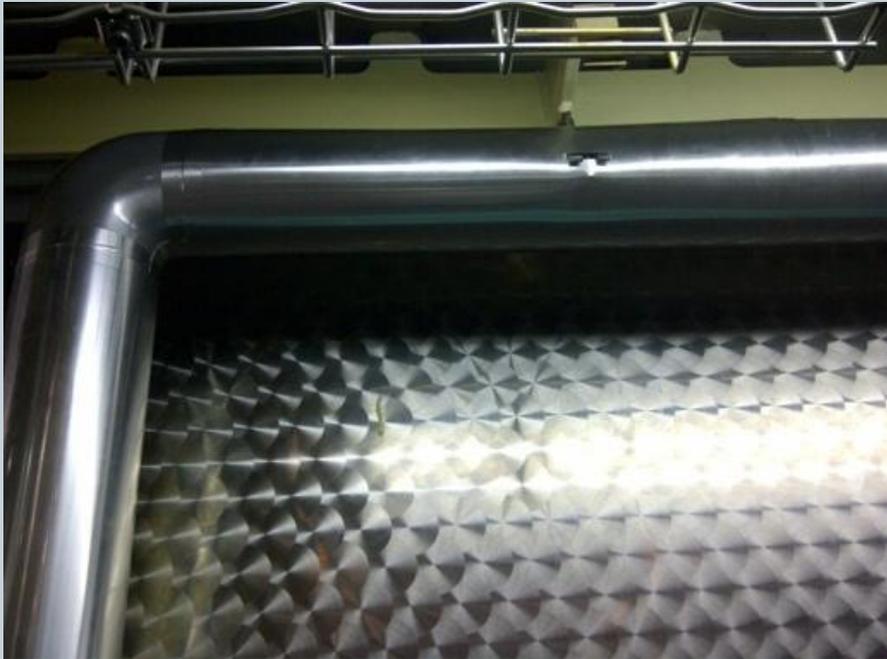
- To the right: bracket is protruding; the cut out for it is less than satisfactory
- To the left: a small incision has been made for the protruding bracket. Silver silicone (food grade) will be used to seal the gap

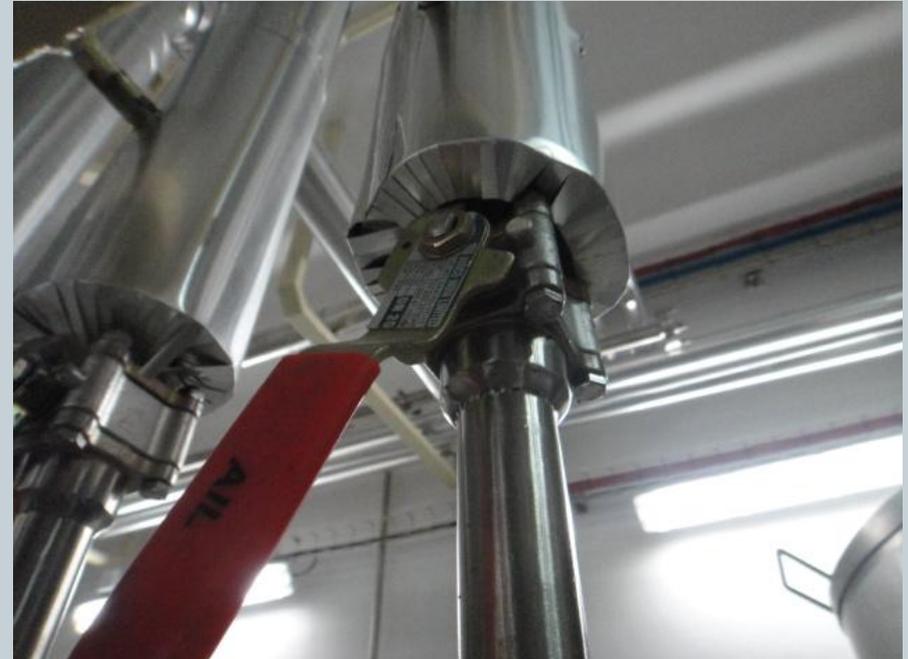
- To the right: End cap missing, the end fabrication esthetically unpleasant, insulation is exposed
- To the left: A prefabricated end cap installed; all must be done in the similar manner; a heat resistance (food grade) silicone may be used to fully seal and act as a membrane between the pipe and end cap

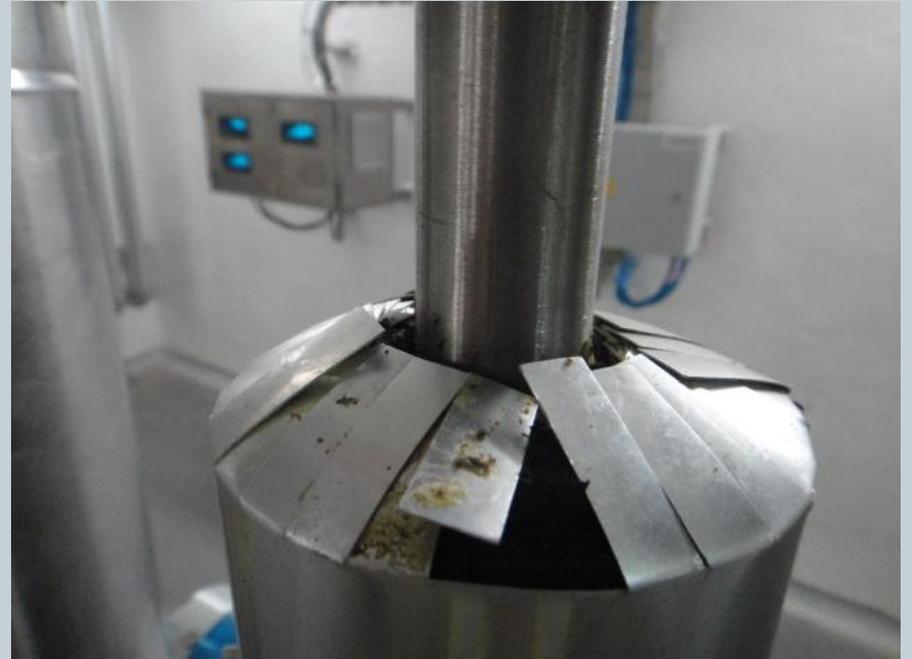
- As per the last 3 slides

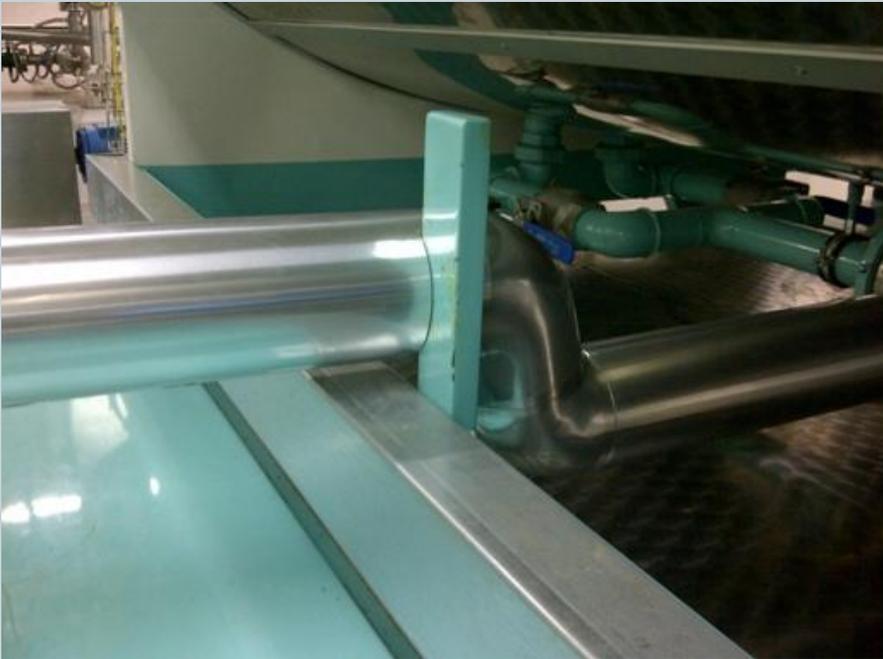
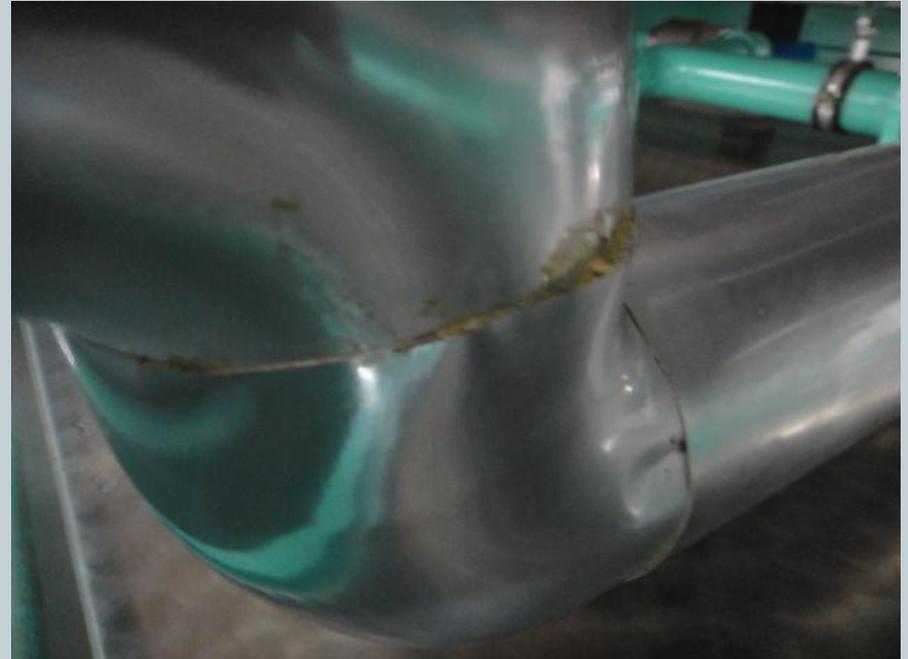
- To the right: glue used to connect the two elbows, gap exposes the glue, esthetically unpleasant look
- To the left: Elbows removed and replaced

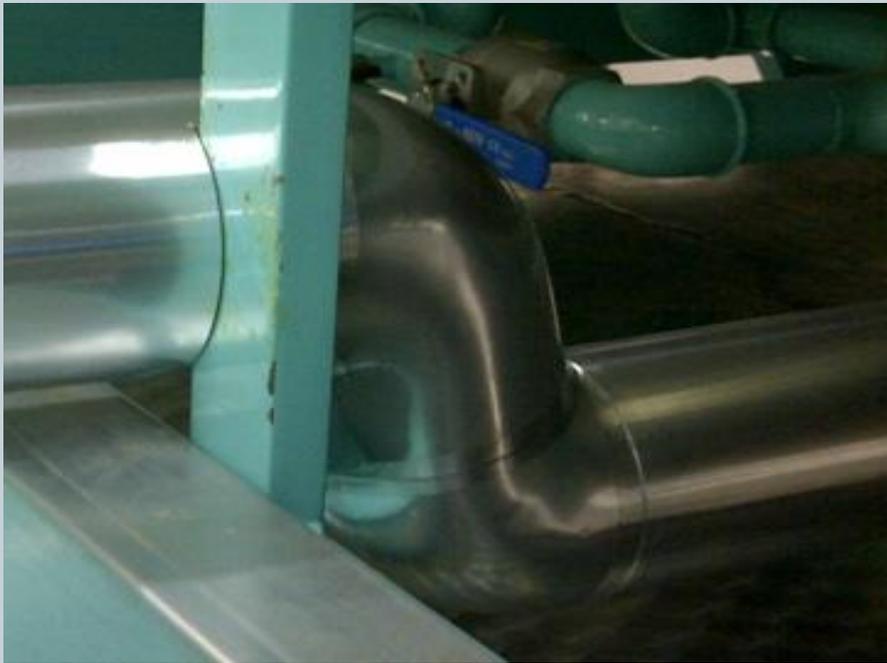
- A close up of the previous slide

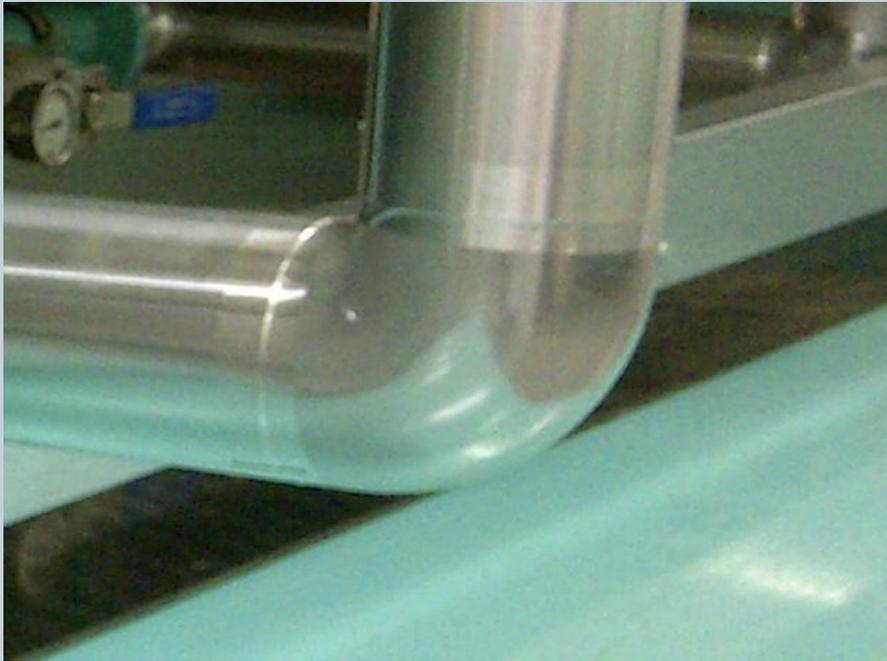
- To the right: tape esthetically unpleasant
- To the left: tape installed flat, no wrinkles present

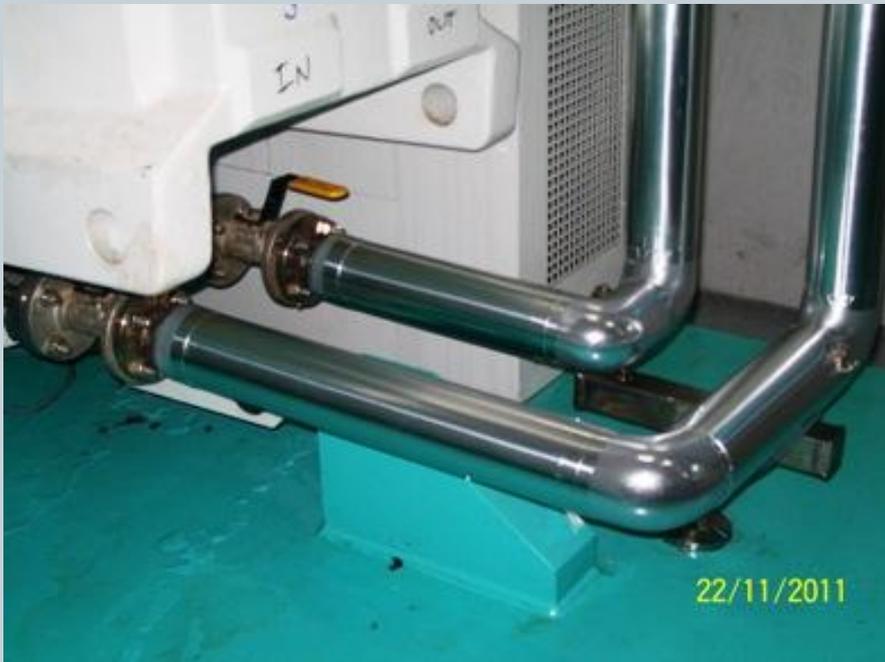
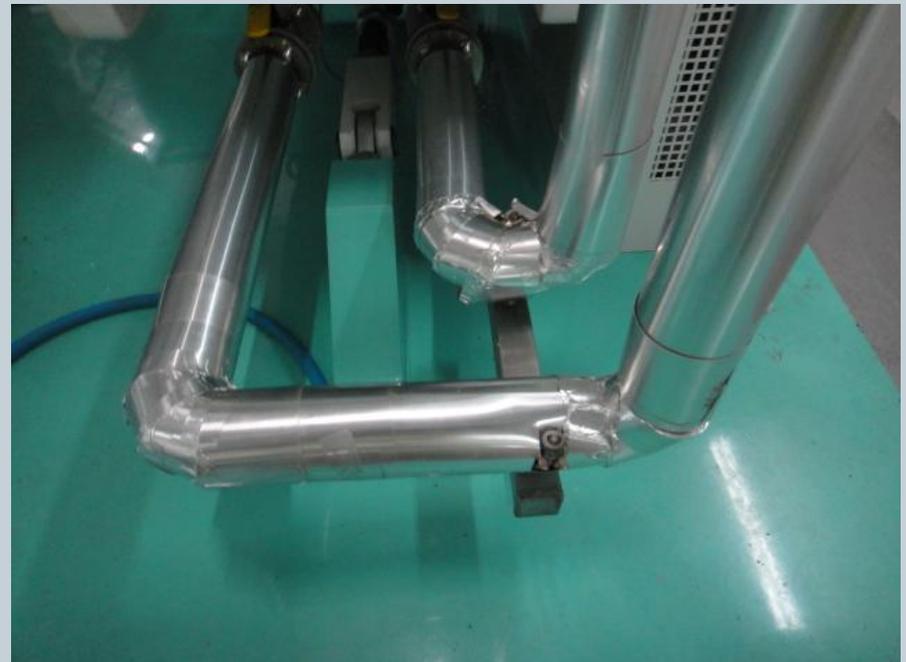
- To the right: proper elbows missing, tape & installation esthetically unpleasant
- To the left: new elbows installed, tape installed flat, no wrinkles present
